Freedom Chemical Spill

- 1/9 spill of 4-methylcyclohexane methanol (MCHM) reported to Elk River
- MCHM detected at intake to WV American Water Company Kanawha Valley Plant
 - Did not shut down intake, concern for pressure loss
 - Minimal storage
 - No alternate/emergency source
- Do Not Use Order issued by West Virginia Bureau for Public Health (WVBPH), Governor Tomblin declares State of Emergency
 - 100,000 customers
 - 300,000 service population
 - 9 counties
- Chemists consult to understand MCHM chemistry, analytical approach
- WVBPH consults CDC/ATSDR on MCHM toxicity

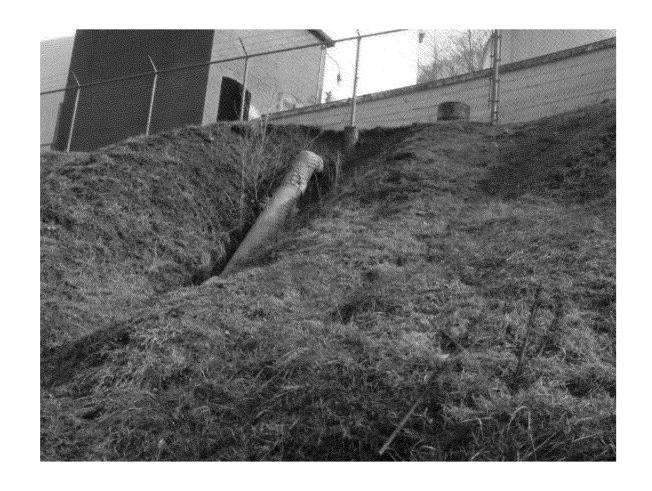
Storm drain below the second containment of tank farm
